# White House Documentation Projects

Frederick J. Lindstrom

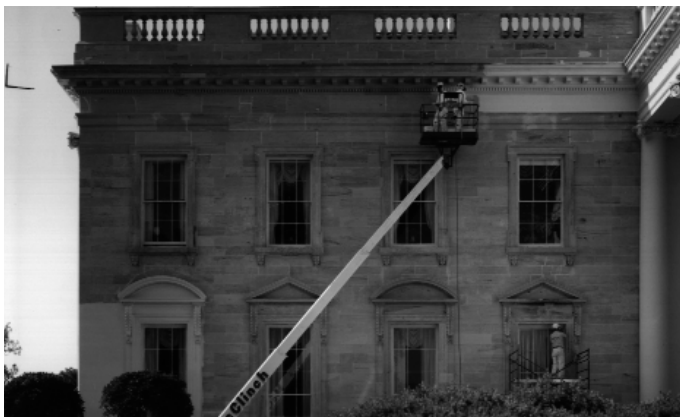
North elevation of the White House being repainted.  
Photo by Jack E. Boucher, 1989, HABS.

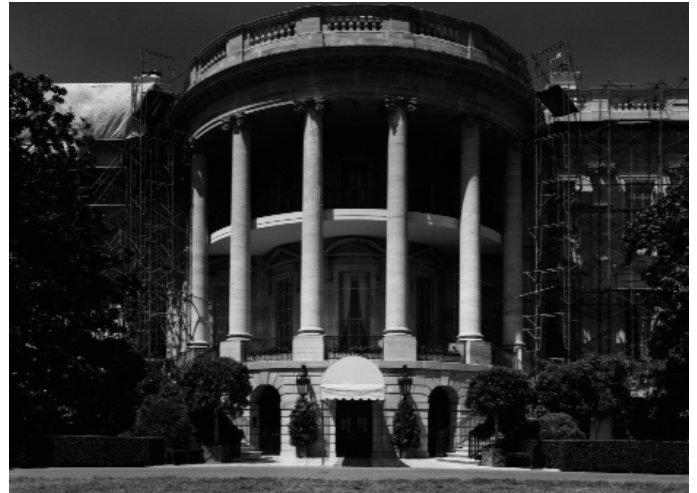
South porch of the White House with the scaffolding of the stone masons.  
Photo by Jack E. Boucher, 1991, HABS.

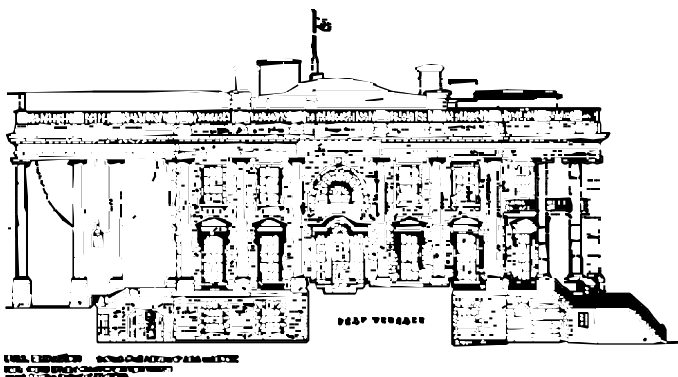
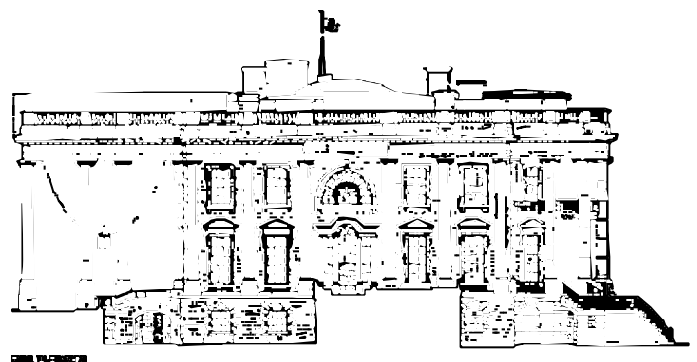
Final HABS sheet of the 1/8" scale reductions of the west elevation with and without the stone graining. All of the elevations were drawn originally at 1/4" to maintain a high level of detail and will appear in the final set in both 1/4" and 1/8" scales. Drawn by Douglas Anderson, Isabel Chia-Ya Yang, Timothy A. Buehner, and Eric Schmidt, 1990-92, HABS.

The summer teams hand measured the previously obscured carved detail and mortar joints. Each stone was measured and overall dimensions of the facades were taken in order to generate existing condition scaled drawings of all four elevations with variations removing the north and south porches to reveal the back walls.

Using prints of the photogrammetric plates produced by Dennett, Muessig, Ryan and Associates in 1984 and 1990 and HABS staff photographer Jack E. Boucher's 5" x 7" large-format, black and white images of the bare Aquia sandstone facing, the teams rendered copies of the base drawings of the elevations with the stone graining as it was revealed. The drawings and photographs of the bare walls are the only record of what the house looks like unpainted. Larger scale drawings of details such as the exquisite stone carving on the north entry doorway, the second-floor fan windows, the two different cornice profiles, and the iron lanterns of the south entrance were produced. Details representing each of the typical window configurations were also generated. These drawings are examples of precision technical delineation.

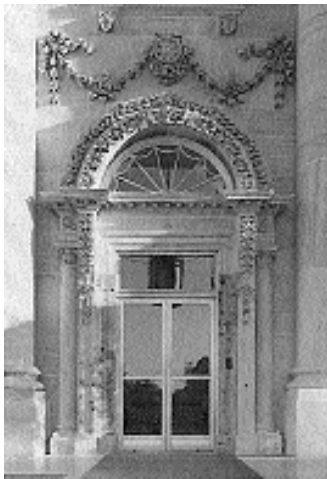
Photograph of the north entry door, stripped of the 32 coats of paint that had occluded the stone carving. Photo by Jack E. Boucher, 1989, HABS.

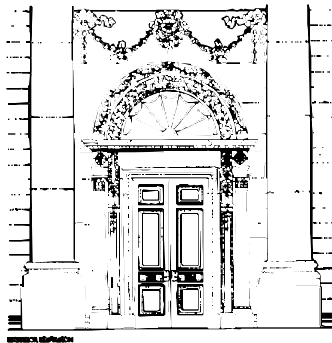
Detail drawing of the north entry door of the White House. Delineated by Richard A. Ventrone, Jr., Timothy A. Buehner, Ronald M. Bailey, Scot C. McBroom, Paul G. Homeyer, and Douglas Anderson, 1989-92, HABS.

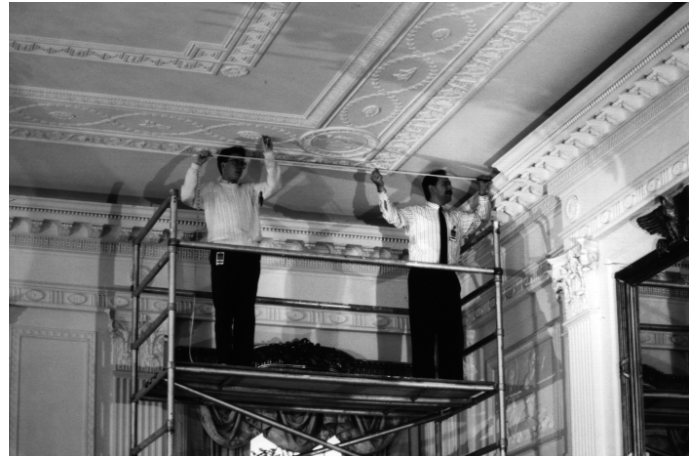
The White House interiors team at work measuring the ceiling of the east room of the White House. Photo by Frederick J. Lindstrom, 1991, HABS.

basic tools for taking dimensions such as measuring tapes, rulers, levels, and plumb lines. A Lietz telescoping Digital Reading Measure Pole was used for ceiling heights, reducing the use of bulky ladders. These methods are labor and time intensive but are highly accurate. The team had to carefully work around the furniture and art objects. Whenever a piece of furniture was blocking access to a detail or a lamp was in the way of extending a measuring tape across a room, the team would have to stop and request the house staff to move the individual piece. This was done only when necessary and many times alternative strategies were invoked to measure around furniture, crystal chandeliers and art work. All dimensions were taken to the nearest 1/8", with some of the more intricate details measured to the closest 1/32". All large-scale details were carefully drawn in the field notes at full scale to eliminate any errors in scale translations.

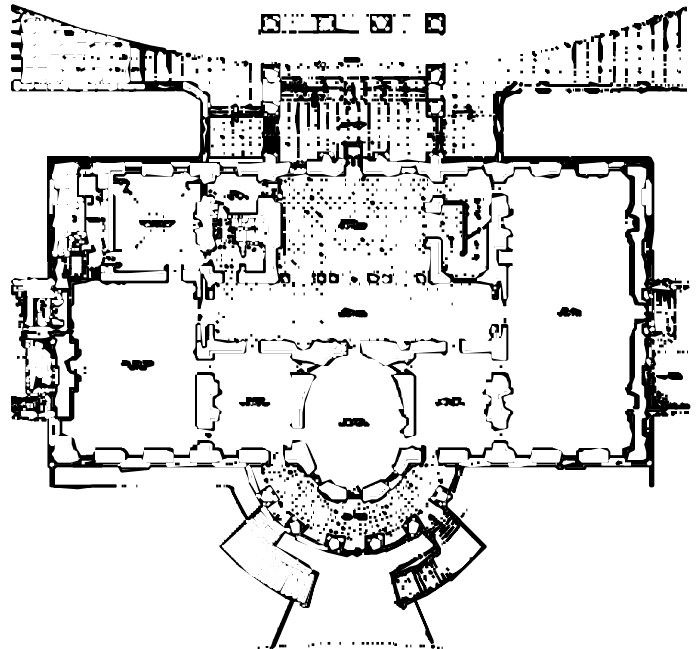
Final ink on Mylar line drawing of the first (State) floor of the White House. Delineated by Gillian B. Lewis, Kenneth W. Martin, and Scot C. McBroom; preliminary by Gillian B. Lewis, 1990-92, HABS.
